DOG IN THE COAL MINE?

A Case Study

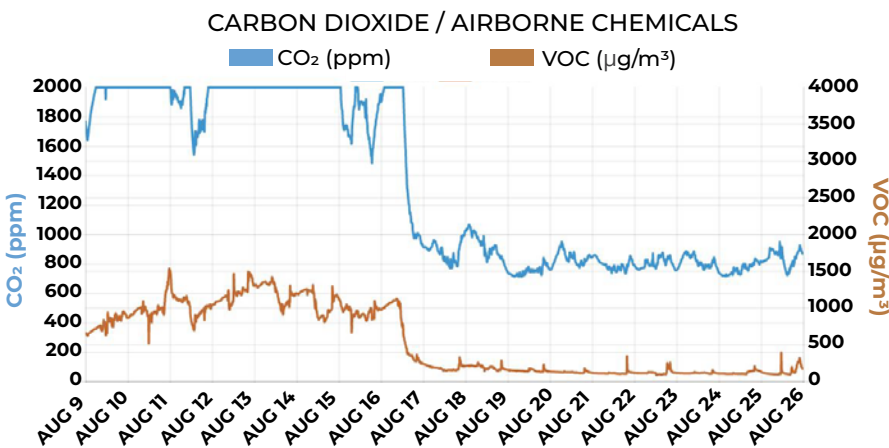
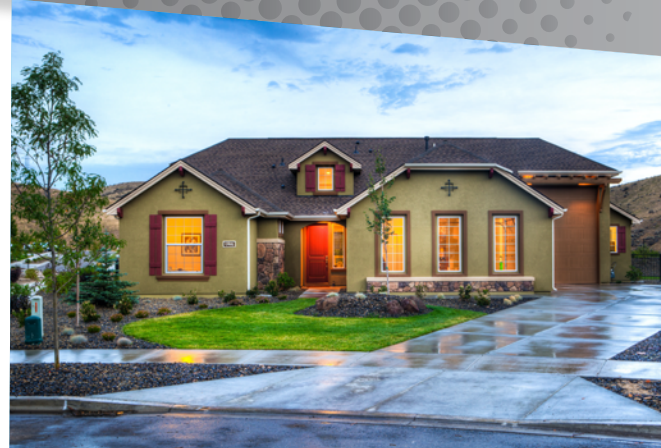
The test revealed elevated levels of airborne chemicals and carbon dioxide. This was a surprise since the home was equipped with a heat recovery ventilator (HRV) to supply adequate ventilation. The HRV had been there since the home was built, and was operating during the test. Armed with this information, Titanium Mechanical performed a thorough visual inspection and found a blockage in the ductwork. Even though the HRV was on, there was no fresh air getting into the house because of the blocked ductwork.

HIGH LEVELS
of harmful chemicals

HIGH LEVELS
of CO₂

Before and after testing demonstrates what a HRV can do when installed correctly, and why we need them in the first place. This family is now better off because their contractor took the time to test the air. And what happened to the dog? He's okay too, his symptoms went away!
